## Power Antenna Rod Replacement

Classification: EL94-002a

TECHNICAL BULLETIN ITB94-014a

December 22, 1994

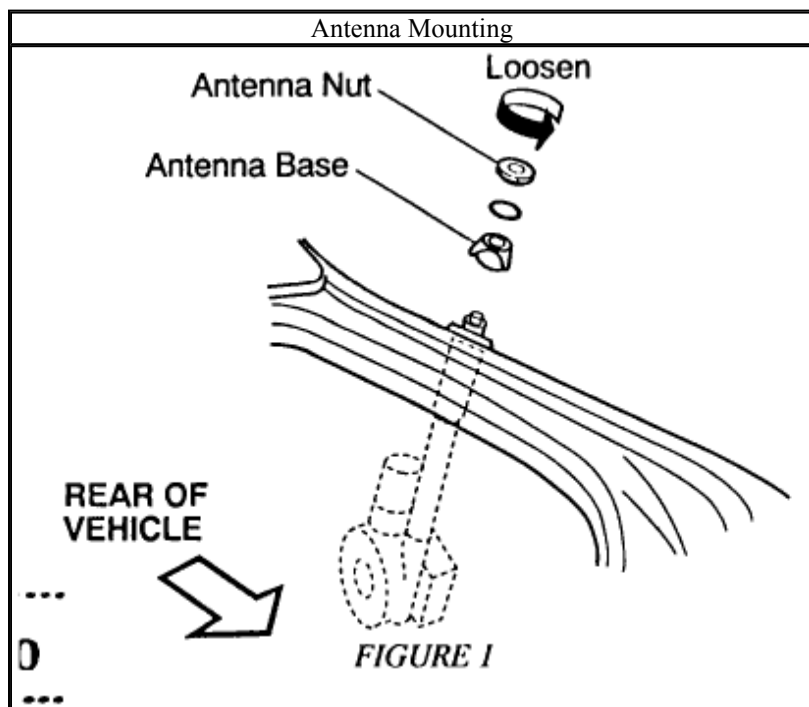
Improper retraction of the power antenna will usually be caused by a bent antenna rod. After ensuring that the antenna motor is receiving proper power and in operational, replacement of the antenna rod is the only repair sequence needed to restore power antenna operation.

1. Remove antenna nut and base. (Figure 1)
2. Turn the radio to "ON" and the antenna rod will extend\*. Assist the antenna rod to fully separate from the antenna base. Note the direction of the gear section on the antenna rope. (The new antenna rod must be installed in the same direction).
