J30 Headlights Acting Strange

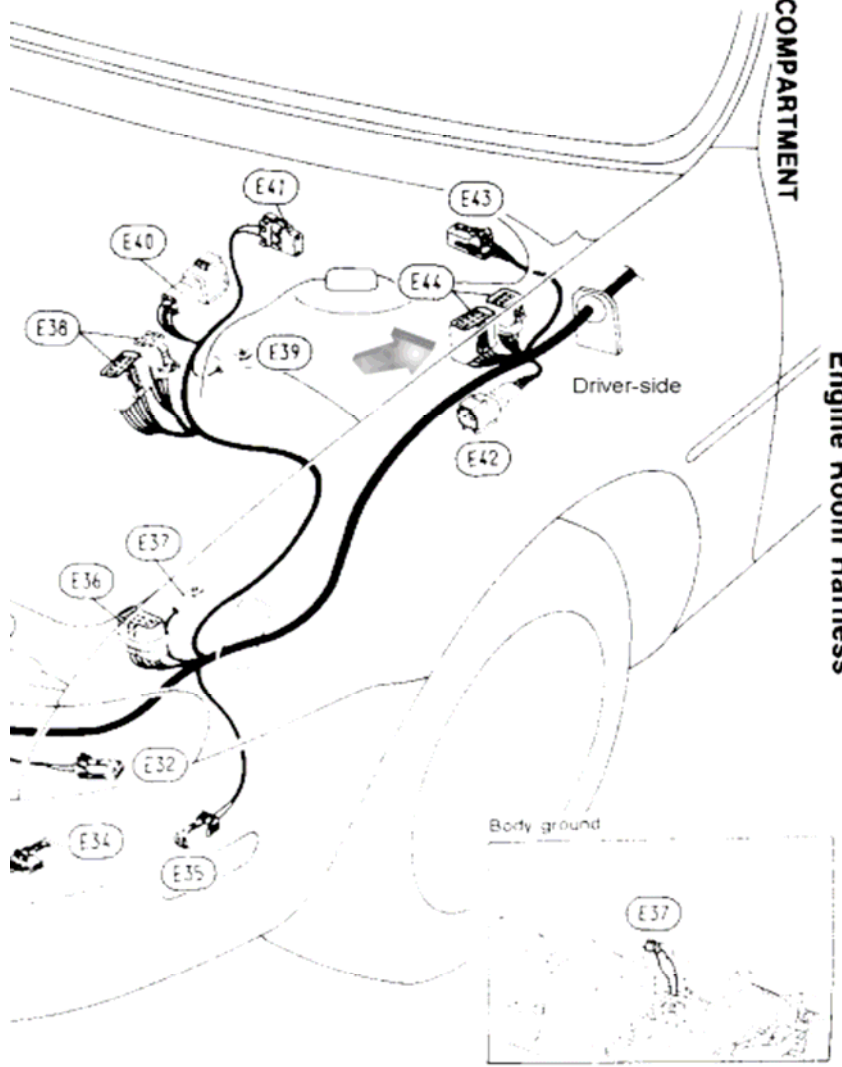
Engine Room Harness

The headlight relay (E44 in diagram below) is located under the hood where the left (driver) fender meets the firewall. The cruise control throttle actuator blocks the access to the relay. The relay is a black box about 3" square with 2 wire connections on the bottom that are not visible until the relay is un-bolted from the left fender. To remove the relay, do this:

HARNES LAYOUT

ENGINE COMPARTMENT
